STATE PROCUREMENT OFFICE
EMERGENCY PROCUREMENT REQUEST

H1 REPAIRS, WEST BOUND MAKAKILO OFF-RAMP AND CAMPBELL INDUSTRIAL PARK OFF-RAMP EMERGENCY PROCUREMENT

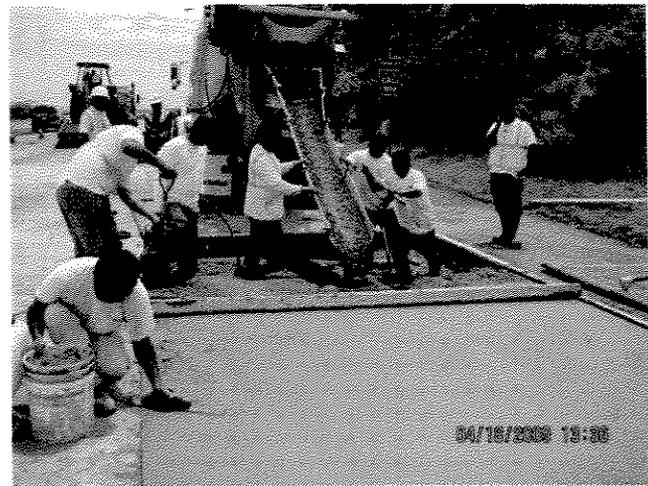
The H-1 Freeway was shut down for emergency repairs over two weekends: 4/17 – 4/19 and 5/29 – 5/31. A section of the middle lane approximately ½-mile from the Makakilo off-ramp had cracked to the point that portions of the roadway had come loose and were observed rocking when heavy trucks traveled over them.

The Makakilo off-ramp was done first. Because of its proximity to Makakilo, in turns of impact to the motoring public this was the worse of the two areas. Although advance-warning signs were in place and PSA were done on both TV and radio, traffic was very heavy during this work. The middle lane was done first, then the right lane. Work started at 10:00 PM Friday, 4/17 and the middle lane was opened to traffic on Saturday night around 9:00 PM. The right lane was opened to traffic Sunday morning, 4/19 around 8:30 AM. Repair covered an area of 1051 square feet and approximately 50-CY of accelerated 650-flex concrete was used and there was a work force of approximately 20 people. The Campbell Industrial Park off-ramp was closed at 10:00 PM Friday, 5/29. This work involved only the right lane (an approximate area of 1392 square feet) and we were able to keep the exit open while working so the impact to traffic was nominal. The accelerated 650-flex concrete mix was used again, and approximately 60-CY were poured on Saturday, 5/31 morning around 10:00 AM. The lane was opened to traffic on Sunday, 5/31 around 9:00 AM. Again the work force was approximately 20 people.

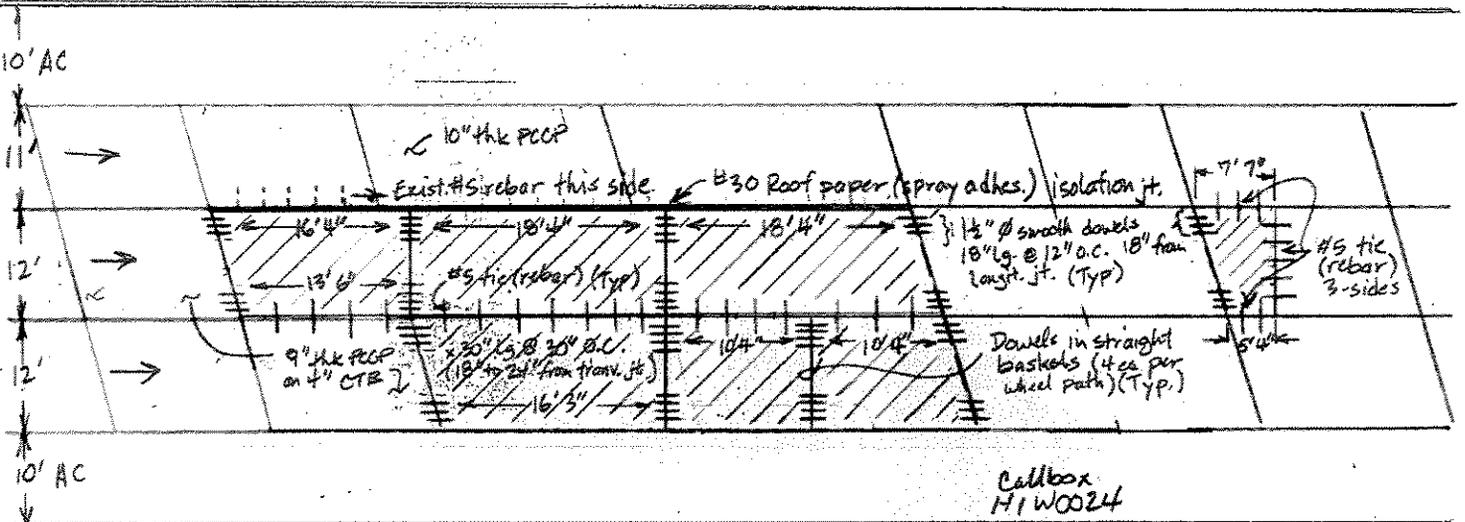
H-1 Westbound Slab Replacement (PCCP) Center and Right Lanes, before Markakilo Off-ramp (Not to scale)

4-17-09 9:00p Closed 2 lanes from NS Rd Bridge (~1 mi). Traffic ~45 min. delay to midnight.
 ~10:30p Start sawcut + demo (late start due to traffic). Hydraulic hammer, 4 dumps, hoptoe. Perennial sawcut + core 30 holes (2" dia.)

4-18-09 Prior to 4:30a: Grade rolled (300# roller) - tamped edges + small PCCP. ~6:00a Coring and tie bars complete + dowels in place.
 7:00a Haw. Cont. notifies Type III NA (plant prob), substitute use of accel. 650 flex (450f, @ 12 hrs) using Type II cont. for both lane.
 ~8:30a 1st truck arrive. Dose w/ Rheoconcrete LWI (calcium nitrate) on site (~15 min. mix). ~9:00a 1st pair. Centerline 3 trucks, ~20 min spf

10:00a: 3rd truck sampled, 10:30a. Complete centerline pour, ~12 noon strip forms, 12:30p sawcut transv. jts.
 1:00p: 4th truck arrives, dose + pour. 1:30p 2nd truck, 2:30p 3rd truck (final right lane pair). 2nd truck sampled

6:00p: Haw. Cont. tested 1 beam @ $f_c = 506$ psi for info only.
 9:15p: Haw. Cont. tested 2 beams (1 Haw. Cont, 1 State) @ 485 + 418 psi (Avg. 451.5 psi). Approx age 11 hrs. Haw. Cont notified

10:00p: Centerline opened, Right Lane remains closed. (OK to open centerline)

4-19-09 8:15a. State Lab test 2 beams from centerline @ 512 + 520 psi flex (Avg. 516 psi). Approx. age 18 hrs. Haw. Cont notified
 State stores 3 beam samples (2 centerline, 1 right lane) scheduled 14 day test. (OK to open centerline)

4-23-09 New slabs - no cracks observed from shoulder. Next Parr: Use fibers (same as Waimuku Bridge wide.), @ 400 psi flex in 8 hrs ±.

1. Use early or rapid setting concrete, and submit concrete mix design for review. Finish matching existing PCCP. Use Lithium Cure D.O.T. curing compound with white pigment. ~~EF~~

2. Transverse Jts.: 1 1/2" dia. smooth davel, 18" long centered across joint*
 at mid-depth of PCCP slab. For dowels at construction joints at exist. PCCP slab, install dowels at depth of exist. slabs. Epoxy coat dowels. Rebar green epoxy coating meeting ASTM D3963 may be used. Lightly grease before pour
 *Critical that dowels are positioned in place parallel to the pavement surface and paving lane direction. Ends of dowels shall not deviate more than 0.01' from parallel in 9" length. [Dowel hole size betw. 1-3/4 to 2 in. dia. [Actual 2" dia. 2 men, 25± min./hole, sawcut transverse jts. after pour, 2 hrs+]

3. Longitudinal Jts.: #5 deformed bar (rebar), 30" long centered across joint at mid-depth of existing PCCP slab, perpendicular to longitudinal joint at a distance of 18" to 24" from transverse joint. Epoxy coat rebar same as smooth dowels above.

4. Spall Area #2: Repair area shall be squared. Sawcut edge of repair area 1 in. depth min. and at minimum width and length of 1 ft. chip-out interior of repair area with a light hammer < 30 #'s. Prepare and fill with early setting grout in accordance with manufacturer's recommendations or Type III cement concrete
